SUPPLEMENTARY MACHINE
SERVICE BULLETIN #112-A.

SUBJECT: Adjustment of Look
for Clear-out Me-
chanism in C and E
Models.

DATE: March 27, 1931.

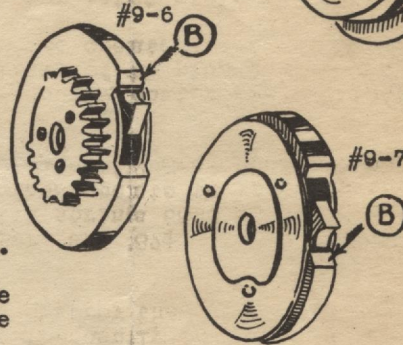
Item 1. When operating the center clear key, if the drum, #9-5, fails to rotate and a clicking sound is noted it is caused by the nose on the #9-11 being held by the edge of the slot in the drum.

Item 2. When operating either the registering dial or counting dial clear key, if the drums, #9-6 or #9-7, do not rotate and a clicking sound is noted, it is caused by either the nose on the #9-12 or #9-13, (or both) being held by the edge of the slot in the drum.

Item 3. When the machine is in regular operation, the #9-11 must hold the #9-5 drum from rotating. On account of the friction applied to the #9-5 there is a possibility of it camming out the #9-11 by contact at point "C".

To eliminate this condition, break the edge at point "A" by stoning until the drum operates freely.

To eliminate this condition, break the edge at points "B" by filing until the drums operate freely.

CAUTION: Do not file the opposite edges of the slots in the drums, and do not file points "B" any more than is absolutely necessary.

This can be eliminated by carefully grinding away the top of the #9-11 as shown by the dotted line.

NOTE: This grinding must not come below the radius of point "C" and should be slightly tapered to the rear of the nose. Grinding should be performed slowly and the part dipped in water frequently to eliminate the possibility of it overheating which would destroy the temper of the material.
